5.7.2 Damage Due to Hydrogen Embrittlement.

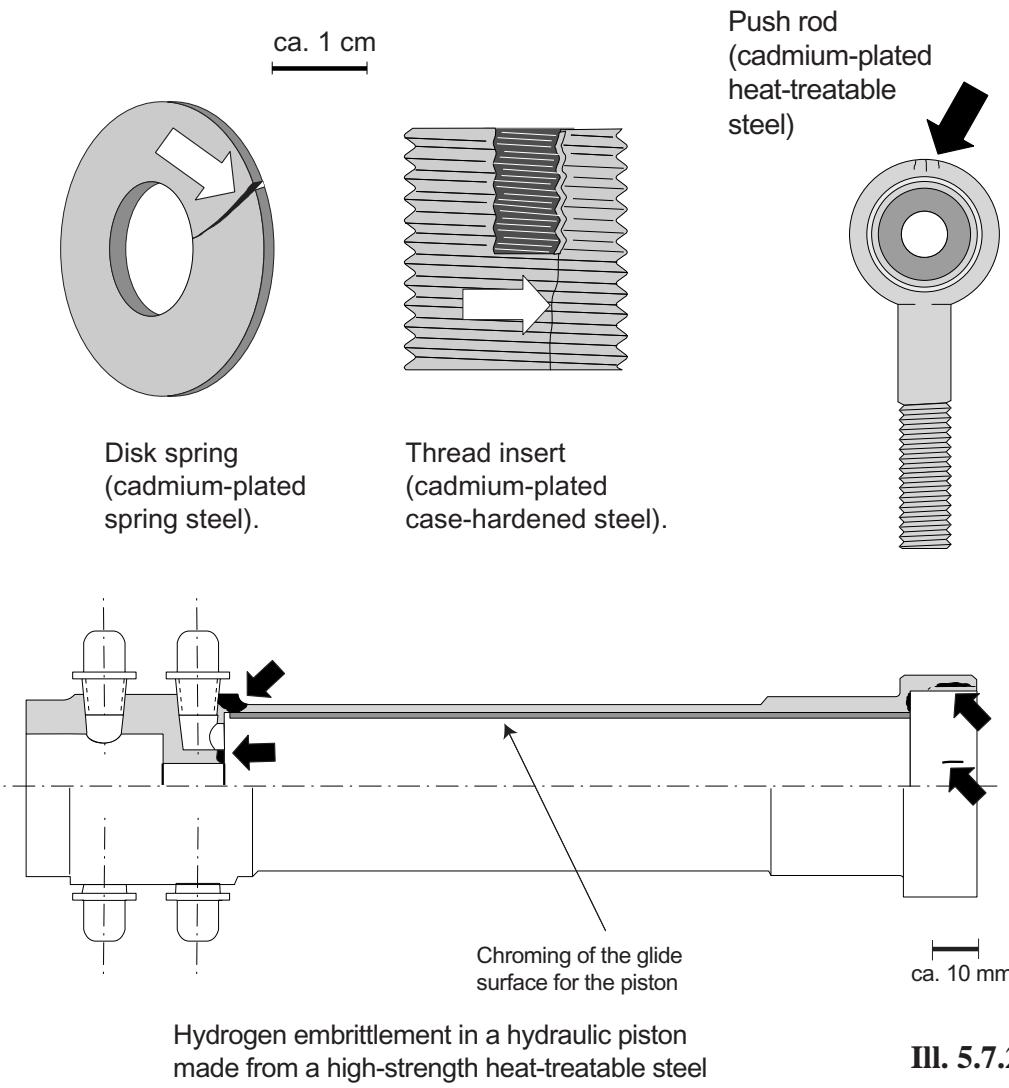
- Cracks and fractures in **cadmium-coated**, hardened/heat-treated steel parts such as thread inserts or disk springs (Ill. 5.7.2-1).

- Brittle fractures in cast parts made from **high-strength steels** (maraging steels, precipitation-hardened steels) in unfavorable material states (Ill. 5.7.2-1)

III. 5.7.2-1: Typical parts in which hydrogen embrittlement damage is frequently reported are hardened or high-tempered parts made from low- and high-alloy steels with **galvanic coatings**, especially **cadmium coatings** (Lit 5.7-15). The supply of atomic hydrogen seems to be especially intense during this process. Typical parts include disk springs, thread inserts, spring washers, plain washers, and threaded rods (top diagrams).

The lower diagram shows a hydraulic piston from a thrust jet adjuster made from a high-strength heat-treated steel. After a restorative **chrome-plating** procedure, certain areas (arrows) that were not chrome-plated developed cracks with typical characteristics of hydrogen embrittlement (Ill. 5.7.1-2).

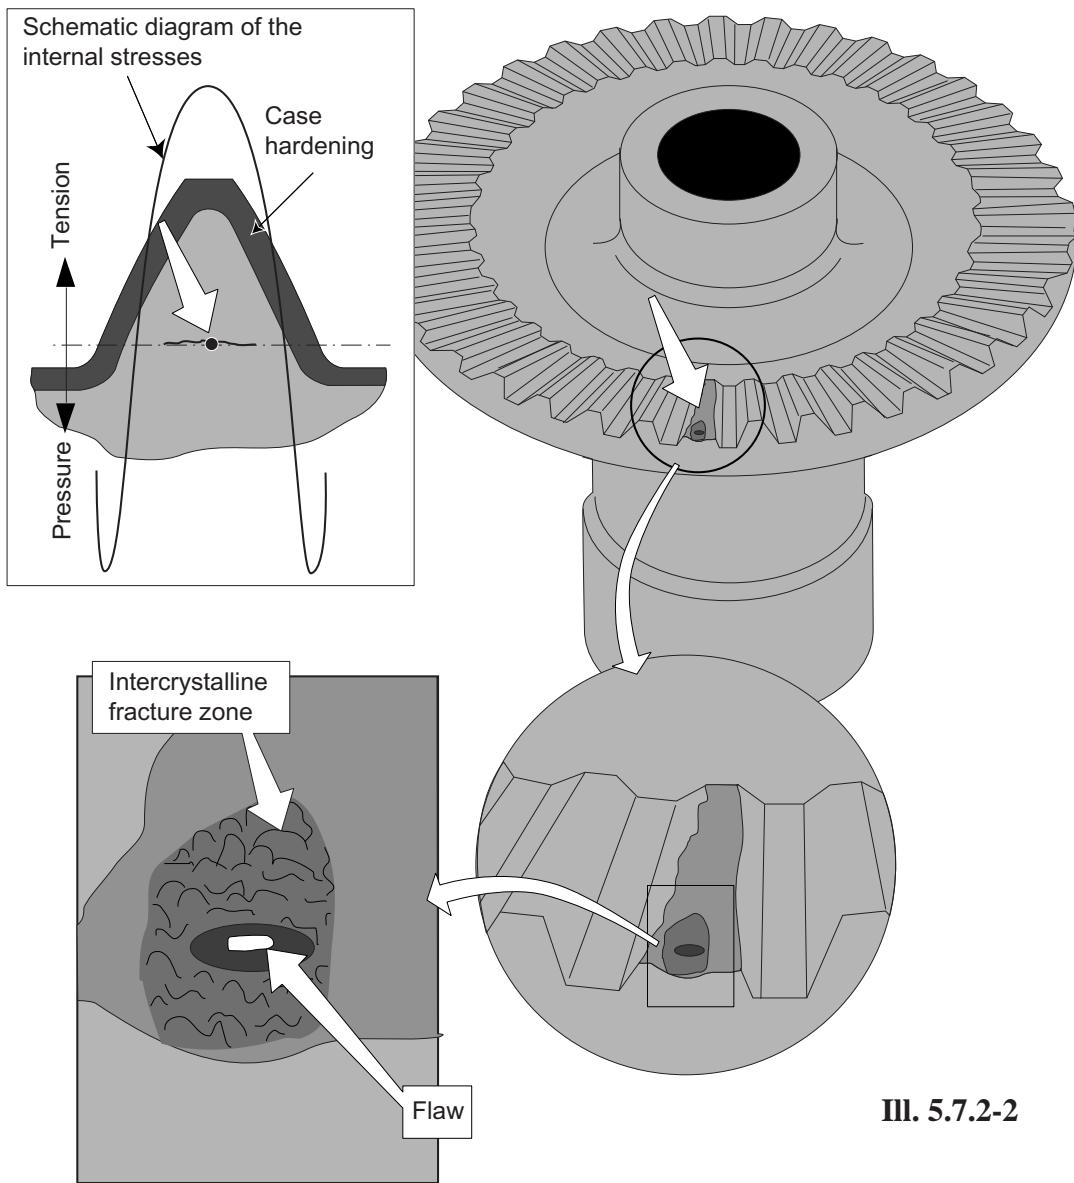
Ill. 5.7.2-2

- Inner crack formation in **case-hardened gears** (Ill. 5.7.2-2) due to hydrogen absorption during **carbonizing** in a gaseous atmosphere (**case hardening**)..

Tooth failure due to hydrogen embrittlement that was related to case hardening.

Ill5.7.2-2: Teeth fractures on **case-hardened gears** due to inner crack development following hydrogen embrittlement. The gears evidently absorb hydrogen during case-hardening (see page 5.7-8). The damage then seems to occur as follows (Lit. 5.7-11): the high internal stresses in the case-hardened layer at the tooth surface induce high tension residual stresses in the tooth

core (top left diagram). The smaller and more filigreed the tooth, the greater the danger that a circular **hydrogen embrittlement crack** will develop at internal notches **within several hours**. An intercrystalline hydrogen-induced brittle fracture then originates in this crack, and can later lead to a **dynamic fatigue fracture** under the operating loads, destroying the gearing.

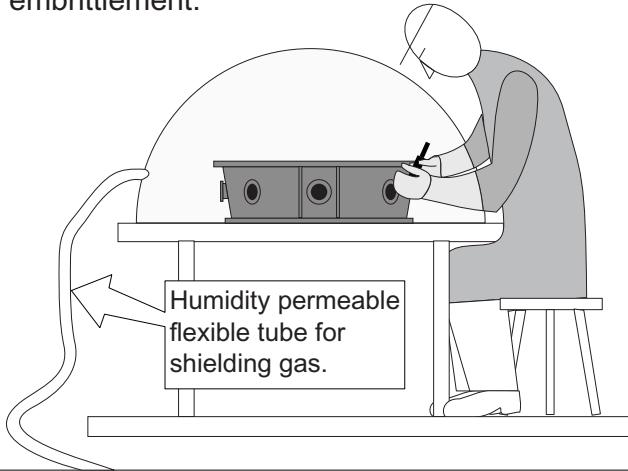
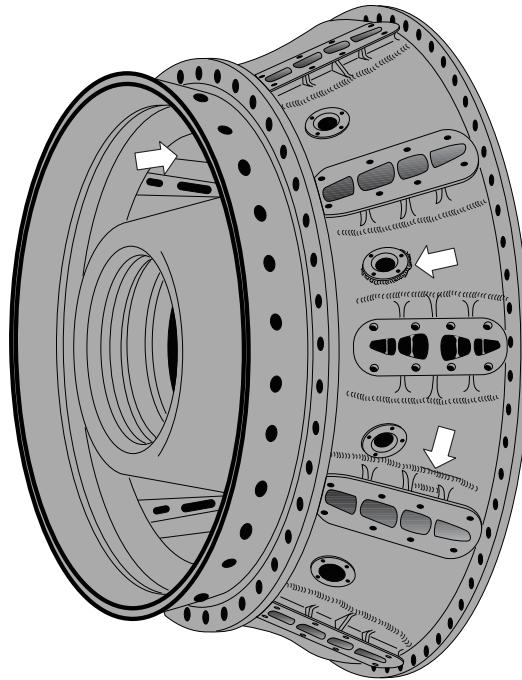
III. 5.7.2-3

- Crack initiation in the **welding seam area** of low-alloy steels after water was absorbed during welding (Ill. 5.7.2-3).

Hydrogen induced crack formation in welds of compressor and turbine casings made from low alloy steels.

Humidity during welding can lead to crack formation during welding due to hydrogen embrittlement.

III. 5.7.2-3: Older engine types often have **compressor housings/casings** that are **welded constructions** made from low-alloy heat-treated steels. Similar housings are found in modern engines near the outlet of the low-pressure turbine. The complex shape of these housings causes them to develop high tension residual stresses that are induced by welding during new part manufacture or repair procedures. If **moisture** (e.g. in the shielding gas or as condensation water) is present during the

welding process (see Ill.5.7.1-3 and volume 4 Ill. 12.2.1.3.1-18), then hydrogen from the moisture can be absorbed by the melt (Lit 5.7-12). This can lead to delayed crack initiation in the weld seam area during storage, manufacturing processes, or operation (arrows show typical crack-prone part zones). For this reason, if this type of crack is suspected, SEM inspections of the fracture surface should be conducted first of all, in order to confirm **characteristic signs of hydrogen embrittlement** (see Ill. 5.7.1-2).

Preventing hydrogen absorption in metal melts during welding and casting by ensuring a dry environment: Drying the welding electrodes (especially with covered electrodes), using dry linings that come into contact with the melt.

Use of dry **shielding gas**. Avoiding use of **water permeable gas feed hoses**. Certain synthetic hoses have been proven to be unsuitable because diffusion of moisture from the outer air.

Drying or sufficiently heating (e.g. above 100 °C) the parts to be welded immediately before welding in order to remove any possible condensation water from the surface.
