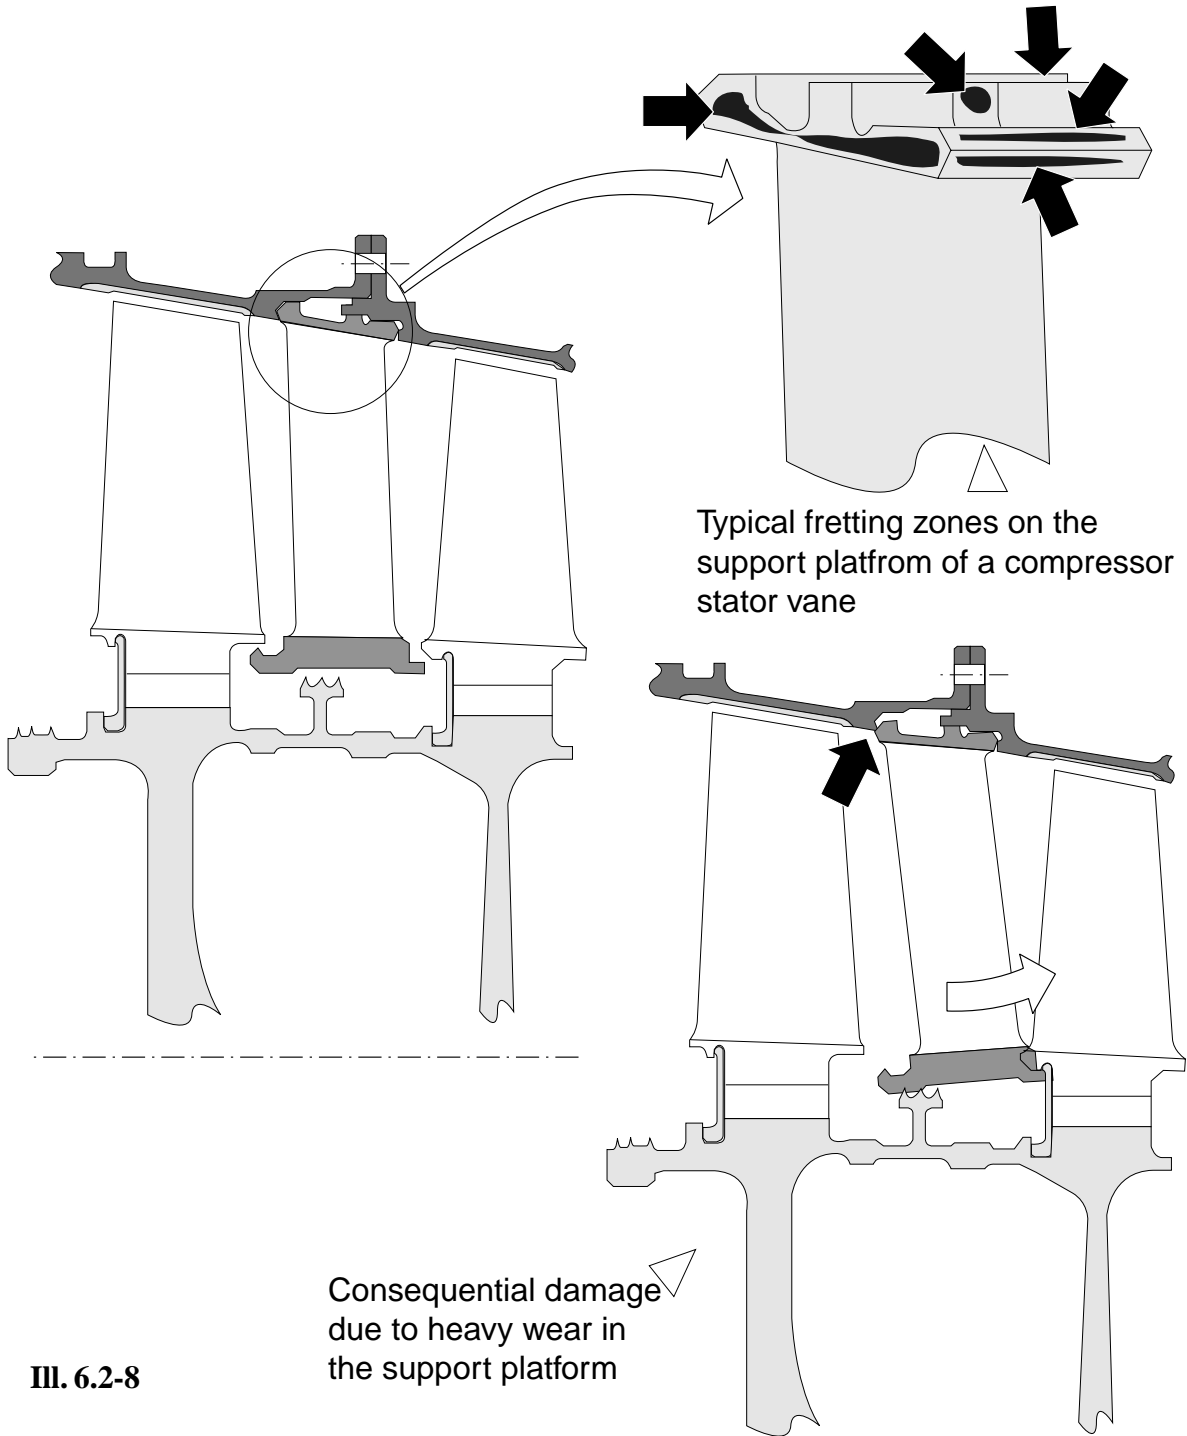
III. 6.2-8

Comment: This excerpt from 1967 concerns a still-recurring problem with **guide vanes** fastened individually or in segments to the inside of casings (compare Ill. 6.2-8). The affected parts are the **T-connections** of individual blades and blade segments. The fretting stress high enough that even steel blades are affected, as in this case. This shows the importance of searching for fretting traces as early as the engine trial stages, so that suitable remedies can be applied if necessary (e.g. coatings, see chapter 6.3)

Illustration 6.2-8: *The connection between **guide vanes** and the **casing** or supporting intermediate structures are typical fretting zones. Not only the unavoidable blade oscillations must be observed, but also **differences of thermal expansion** between casings and blades. Different thermal expansion and/or temperature differences cause the connection to loosen, if only for a short time, allowing glide wear and impact wear to occur. These influences must be considered when testing a tribo-system and can affect the selection of possible coating materials. Although dynamic cracks are less likely in the roots of guide vanes than in rotor blade roots, they can still occur, and the geometric wear can offset the blade. If this happens, the blade may come into contact with the rotor. In extreme cases the **blade or blade segment may fall out.***

Typical wear zones and consequential damag-
-es due to fretting in compressor stator vanes.

For this reason, even new parts made of titanium alloys in fretting-susceptible zones should be armored with an anti-wear coating (e.g. tungsten carbide).
