### III. 8.2-3.2

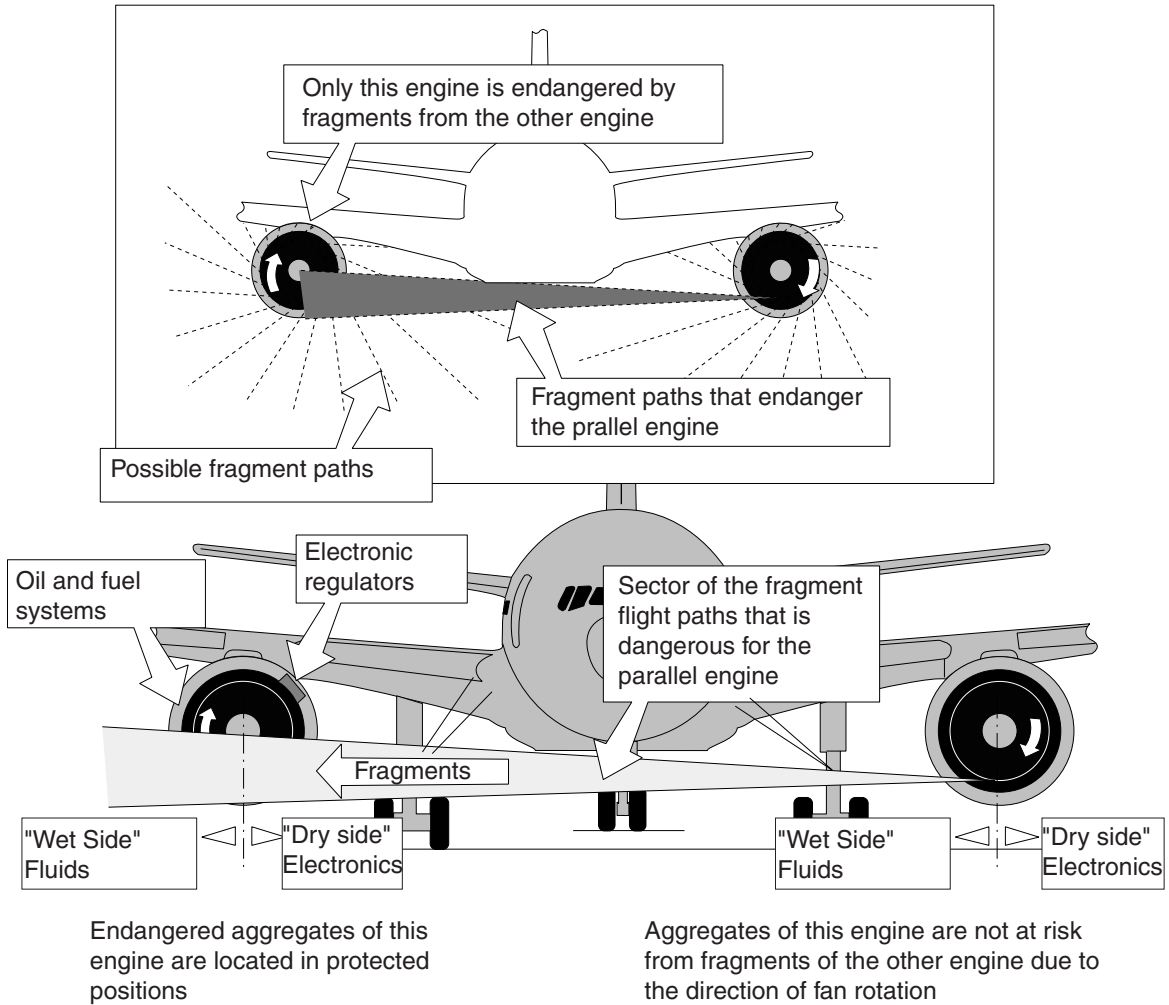
Safe positioning of the auxiliary components depends on the direction of rotation of the fan.

*Illustration 8.2-3.2: In order to avoid failure of both engines the **mounted components, such as electronic regulators and oil and fuel systems on the side of the engine**, should if possible be mounted on the engine in such a way that the probability of them being damaged by fragments from the parallel engine is minimized (see ETOPS, Volume 1 Chapter 3). To this end, it is important that in twin-engine aircraft, **only one of the two wing-mounted engines** has the potential to damage the other due to possible fragment trajectories (top diagram). The fact that only one of the engines can damage the other is due to the direction of rotation of the shafts being the same and the parallel arrangement of the engines. This makes it possible to position the ancillary equipment suitably (bottom diagram).*
