# Operating Loads and Material Behavior Dynamic Fatigue: HCF Damage

Fracture of an integral turbine disk following disk vibrations. Excitement through a flow disturbance.

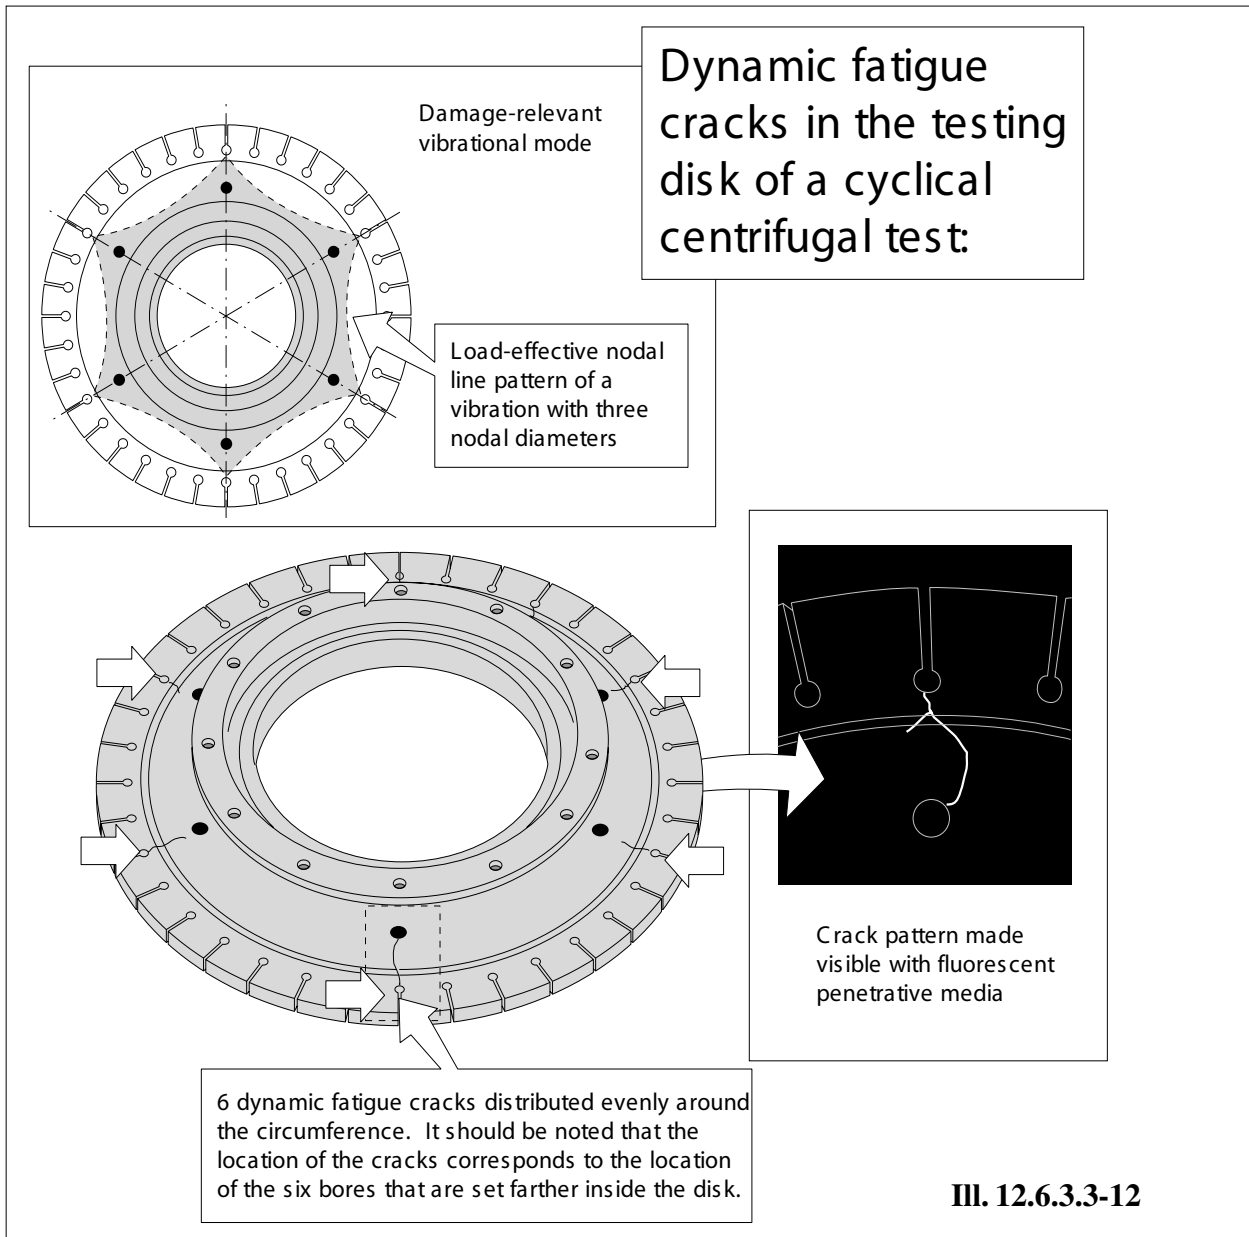
**Illustration 12.6.3.3-12:** The vibration excitement of a rotor disk can also occur with flexural modes of the rotor. In the depicted example, a specimen disk was cyclically stressed in a vacuum vertical centrifugal testing rig by an **annulus that had been “drained”** by keyhole bores (to simulate blade loads). After a short operating time, penetrative crack detection discovered several cracks (right diagram) in the annulus area that were primarily radially oriented and periodically distributed (bottom left diagram). The findings from the crack surface inspection indicated dynamic loads in the HCF range. This was plausibly

explained by a **disk vibration** with three nodal diameters. The vacuum in the testing rig made vibration excitement due to aerodynamic forces impossible. However, there was also no effective air damping. Therefore, the only possible excitement was from the testing rig spike that powered the disk. The spike is elastically suspended in the testing rig on the free end, together with the disk. In the case of imbalance, it runs into a safety bearing. Evidently the rotor vibrated within itself in a way that no externally noticeable imbalances occurred.

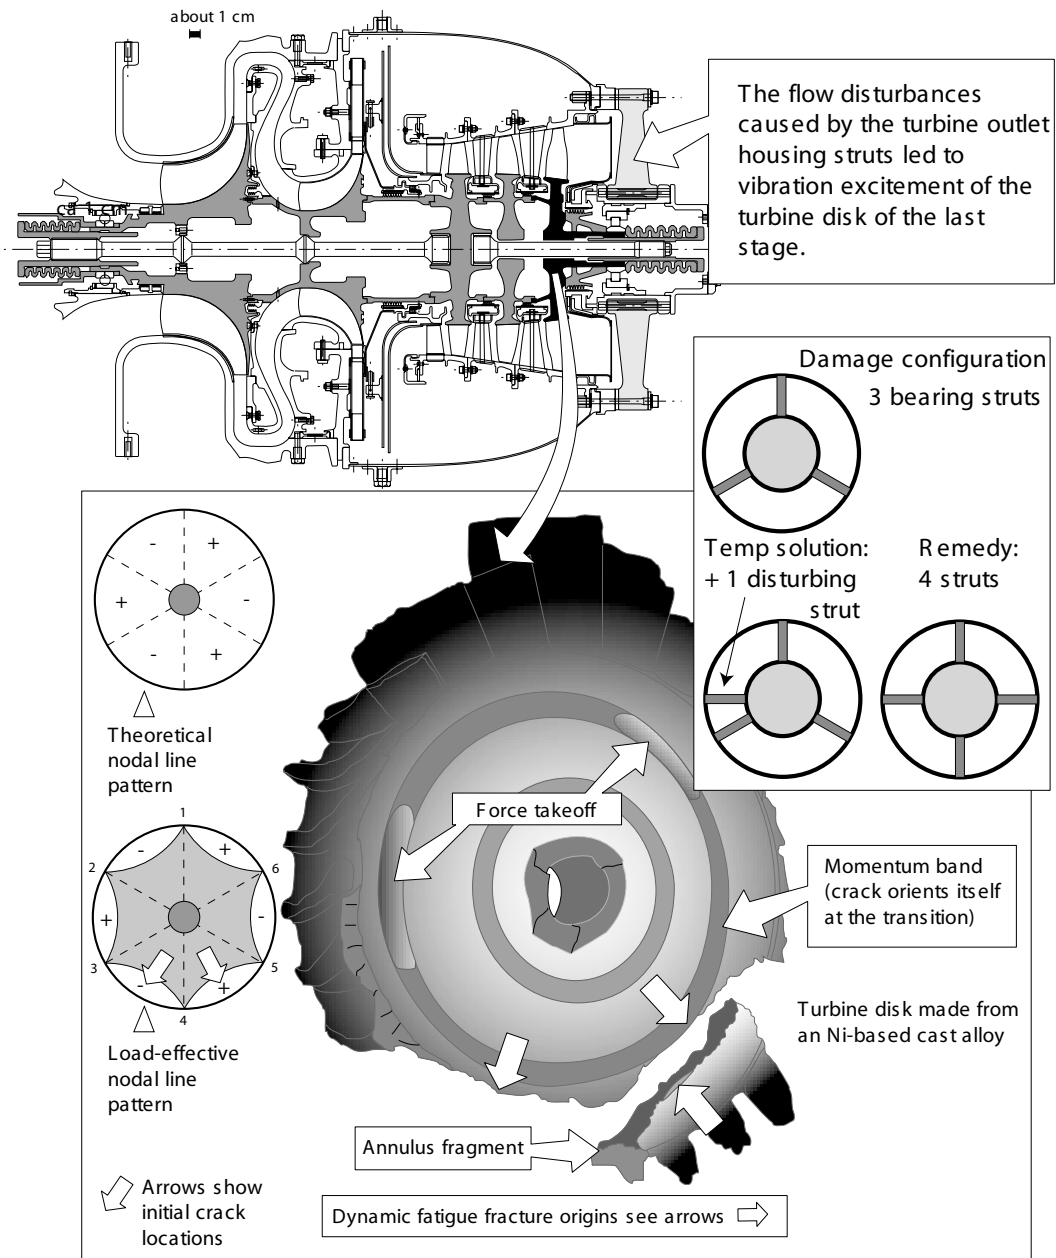
III. 12.6.3.3-13

*Illustrations 12.6.3.3-13 and 12.6.3.3-14: This case occurred during the development phase of a small, low-performance turbine for a helicopter (top diagram). Without any indication of imbalances or other anomalies in*

*operation, the integral cast turbine disk of the last stage burst at full RPM in a steady operating state. Fragments of the annulus had broken off the disk. The entire fracture surface could be seen as a combination of two*

fractures that ran together at an angle to one another that was tangential to the balancing ring (bottom diagram). The fracture surface analysis revealed a bow-shaped limited fracture zone in the middle of each of the annulus fragments near the balancing ring. It also showed stage 1 characteristics (cleavage cracks) that are typical for this Ni-based cast material (Ill. 12.6.3.2-4). A **testing-technical vibrational analysis** (Ill. 12.6.3.3-14 ) with heaps of powder resulted in a distribution pattern that corresponds with the bottom left diagram. This **Chladni figure** showed that a three nodal diameter vibration (Ill. 12.6.3.1-8)

is excited exactly at full RPM by the three bearing braces of the exit housing located behind the disk.

A successful provisional solution was the installation of a **disturbing brace** with no load-bearing function. It was only intended to dampen the vibration in the right rhythm with a disturbing pulse. The final solution was four equally-spaced supporting braces, from which no dangerous excitement was expected (middle diagram). The effectiveness of this solution was confirmed by later experience.
