Problems with Blanks and Semi-Finished Parts: Problems and Damage

Fracture of a compressor rotor due to a material flaw:

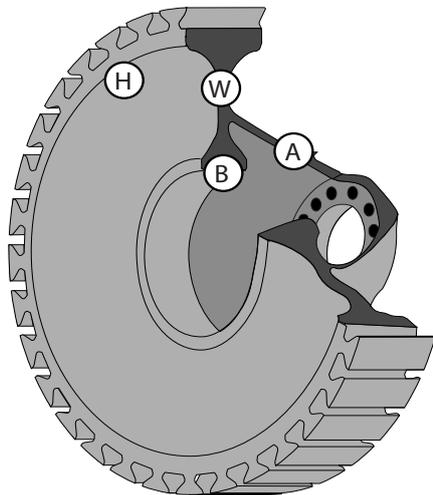
Ill. 15.2-15

Illustration 15.2-15 (Ref. 15.2-30): The analysis of flaws in rotor parts made from a titanium alloy in the time period before 1990 resulted in the following conclusion: the frequency of flaws from the melting process (Ill. 15.1-12) and the forging process (Ills. 15.3-12 and 15.3-13) is not equal throughout the entire part volume. One can see that **dangerous flaws** occurred, or at least were discovered, **especially in the hub area**. This type of flaw distribution is also valid for Ni-based alloys and high-alloy steels produced in similar processes. Flaws in the hub area are especially relevant to safety. This area is typically subject to very powerful cyclical loads. In addition, in the thick hub cross-sections, it is more difficult to realize the plastic deformations during forging that are required to achieve the necessary strength properties (Ills. 15.1-14 and 15.2-11). This deformation is a prerequisite for the smashing of flaws (impurities, also see Ill. 15.1-16) and/or giving them a favorable orientation relative to the main load direction (Ill. 15.1-13). If the deformation is not sufficient, larger flaws in more effective positions are more likely. About 80% of the burst rotors had crack initiation weak points below the surface. The

LCF cracks grew towards the surface. This meant that dangerously large cracks could only be detected at an advanced stage through penetrant testing. Of course, it was a prerequisite that this type of testing occurred during this growth phase of the cracks, such as during overhauls.

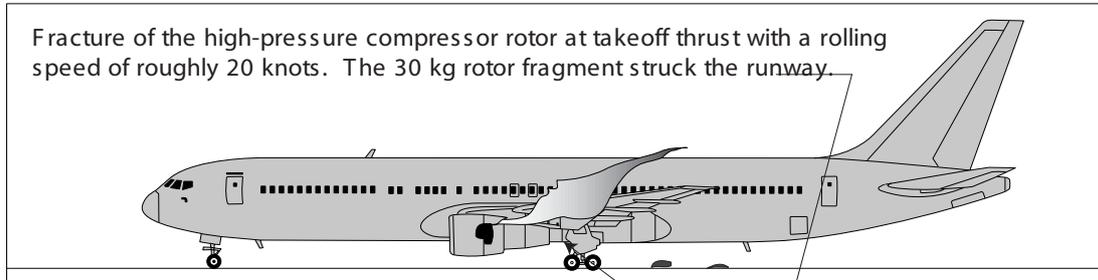
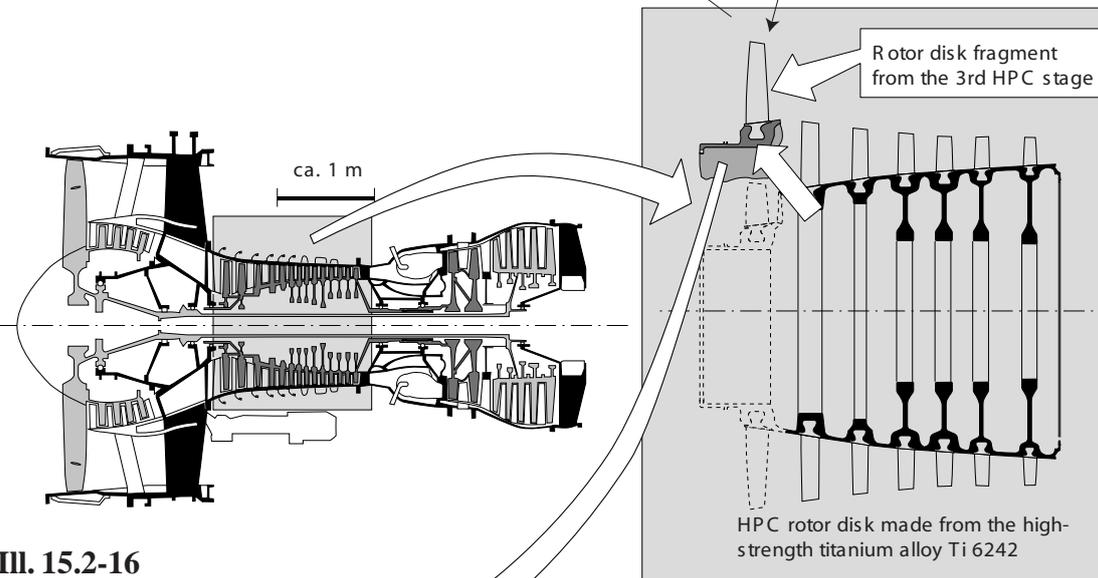
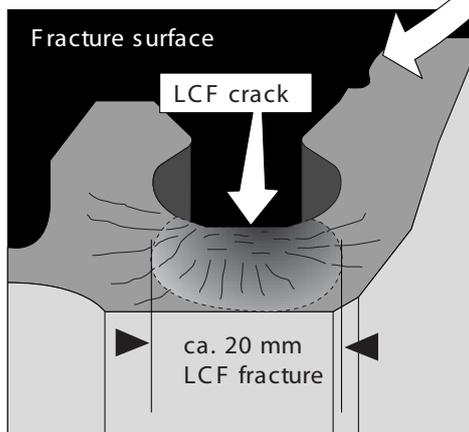
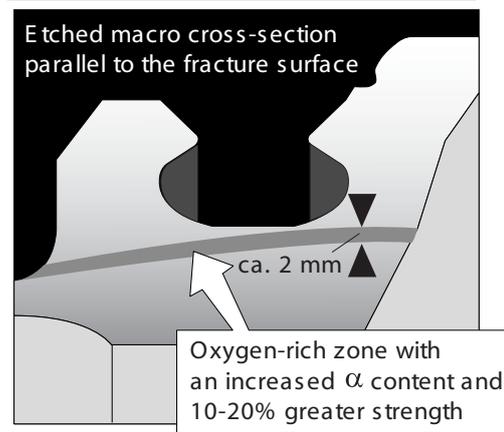
Ill. 15.2-16

Illustration 15.2-16 (Ref. 15.2-18, Example 15.2-3): The one-piece compressor rotor (spool) made from the high-strength titanium alloy Ti6242 failed between the third and ninth stages (middle right diagram) due to LCF (bottom left diagram). The crack was traced back to a

decrease in dynamic strength in the area of an oxygen accumulation (segregation, bottom right diagram) with an increased proportion of α -structure. The flaw area had a slightly higher hardness of R_c 38-43 relative to the matrix

hardness of R_c 34. This was most likely a **Type II, Category 3** flaw (Ill. 15.2-14). The weak point was near the highly-stressed circumferential dove-tail groove.

The oxygen accumulation occurred during the triple remelting process. A possible cause was a pronounced vacuum loss during the second remelting process. This occurrence could be reconstructed with the aid of the required documented process records (Ill. 15.3-10). It is rare for such a process to occur with unallowable intensity. It occurs when the electrode shifts to a cooling water leak in the mold. However, the pressure increase was still within the limits that were tolerable at the time the raw material was produced (1972). The oxygen from the water, which dissociated at the high temperature, then diffuses into the melt bath (Ill. 15.2-17).

This type of weak point with no cracking could evidently not be found through ultrasonic testing due to its unique location. The flaw, insofar as it spread to the surface, would have been detectable with the aid of macro-etching (blue etch anodizing = BEA). However, this process was not yet in use at the time.

Even in the finished part with potential cracking, ultrasonic testing during an overhaul or inspection was problematic. The flaws in the groove area were in a location that was most unfavorable for ultrasonic testing (blind spot). This is especially true of cracks that are located directly below the surface. During the last overhaul, ultrasonic testing showed anomalous findings, but they were categorized as allowable in accordance with regulations. For this reason, additional eddy-current testing was recommended for the detection of cracks near the surface.

The uncontained failure of the third stage of the 3-9 high-pressure compressor spool was due to the presence of an **oxygen rich segregate...**

Typical characteristics of such a procedural deviation were attributed to the damaged part. This made it possible to identify other potentially threatened parts that were located near the damaged part in the casting block (also see Ill.15.2-22). In compliance with the demands of the responsible authorities, all suspect parts (21) were removed within 30 days.
