Abrasive blasting and etching before a penetrant inspection can lead into a dilemma.

An aged or contaminated process bath can dangerously deteriorate/damage coatings/platings.

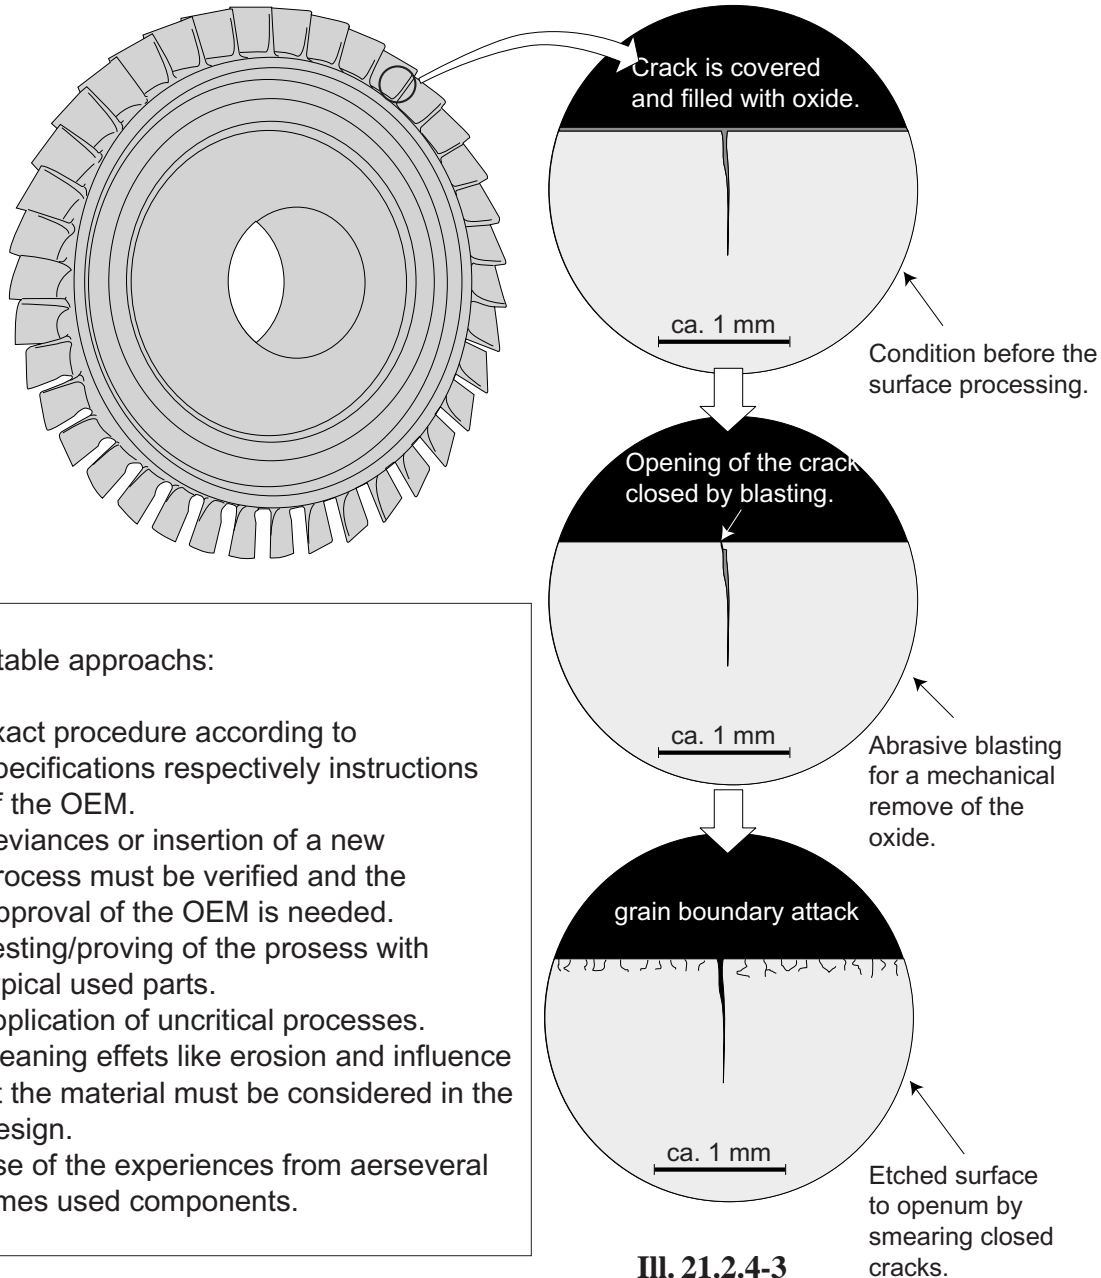
III. 21.2.4-3

*III. 21.2.4-3: There are different effects of surface treatments which can **affect the penetrant inspection** (volume 4, chapter 17.3). As well **abrasive blasting** as also **shot peening** can **close cracks and porosity** (detail middle).*

*With this the penetrant fluid can no more intrude as necessary for the testing process. A further effect is the **roughening of the surface**. It can trigger a „**background fluorescence**“. This covers optically the crack indication. This*

effect develops, when the rough surface if so with overlaps adheres penetrant fluid.

To open „smearings“ etching is used after blasting/peening. If this causes an increased roughness this can mean also disturbing background fluorescence.

Etching is used to remove covering oxide layers and oxidation in cracks (detail above) and pores before a penetrant inspection. Tereby a further problem in a crack like, mostly **intercrystalline attac** emerges (detail below, Ill. 21.1-12 and Ill. 21.2.4-2). This damage even in an already dangerous size not yet detectable with penetrant inspection.

Suitable approaches:

- Exact procedure according to specifications respectively instructions of the OEM.
- Deviances or insertion of a new process must be verified and the approval of the OEM is needed.
- Testing/proving of the process with typical used parts.
- Application of uncritical processes.
- Cleaning effects like erosion and influence at the material must be considered in the design.
- Use of the experiences from several times used components.

Approaches for a **risk minimization** are contained in the frame at the left.

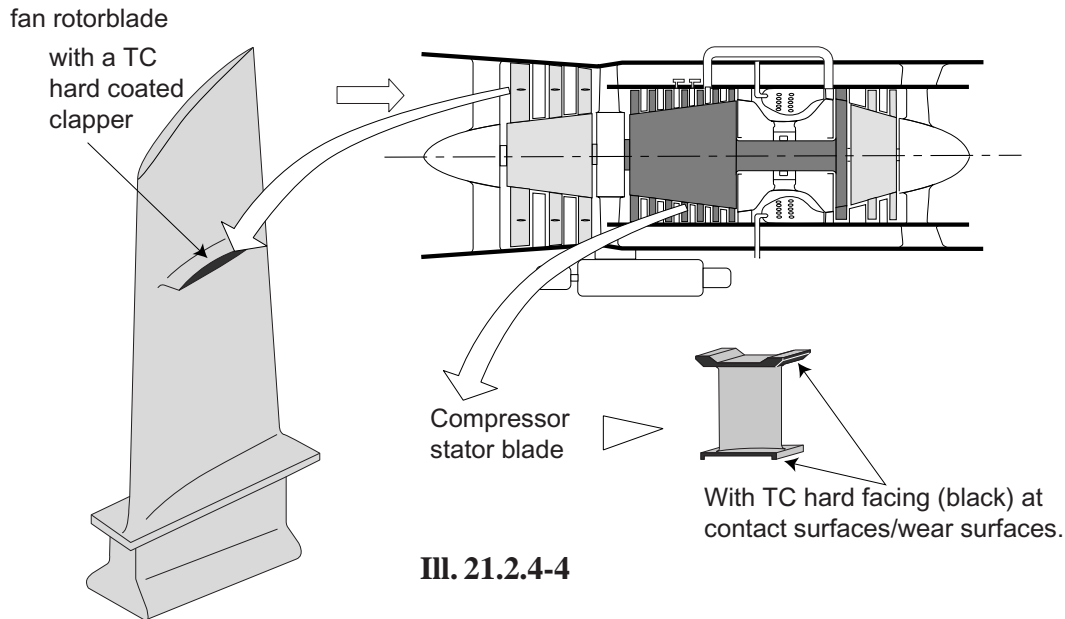
Ill. 21.2.4-4: Aged or contaminated process baths like etching baths and cleaning baths can dangerous damage materials, which they else don't attack. This danger of **repairs** is expecially high. The cause is, that used, possibly already at former times repaired parts in **contrary to new parts** can have unknown or undetected contaminations.

In the shown case in a short time period it failures occurred repeatedly at a multitude of parts during repair (volume 4, Ill. 16.2.1.7-8). Concerned was a proven process bath in which **TC/Co-wear protection coatings** are normally not attacked. These coatings are at parts of a tanium alloys from the compressor have been suddenly dissolved (?).

Investigations showed, that probably a **contamination with copper** was the cause for the aggressive behaviour of the bath.

Note: To a repair respectively repair development belongs also the **testing and the proof** of suitable **non destructiv testings** which guarantee the safety.
